**STAFF REPORT
HISTORIC AND CULTURAL LANDMARKS COMMISSION
CITY OF FORT WORTH, TEXAS**

DATE: July 13, 2015

LOCATION 1511 East Cannon Street

**CITY OF FORT WORTH
CODE COMPLIANCE DEPARTMENT
BUILDING SURVEY**

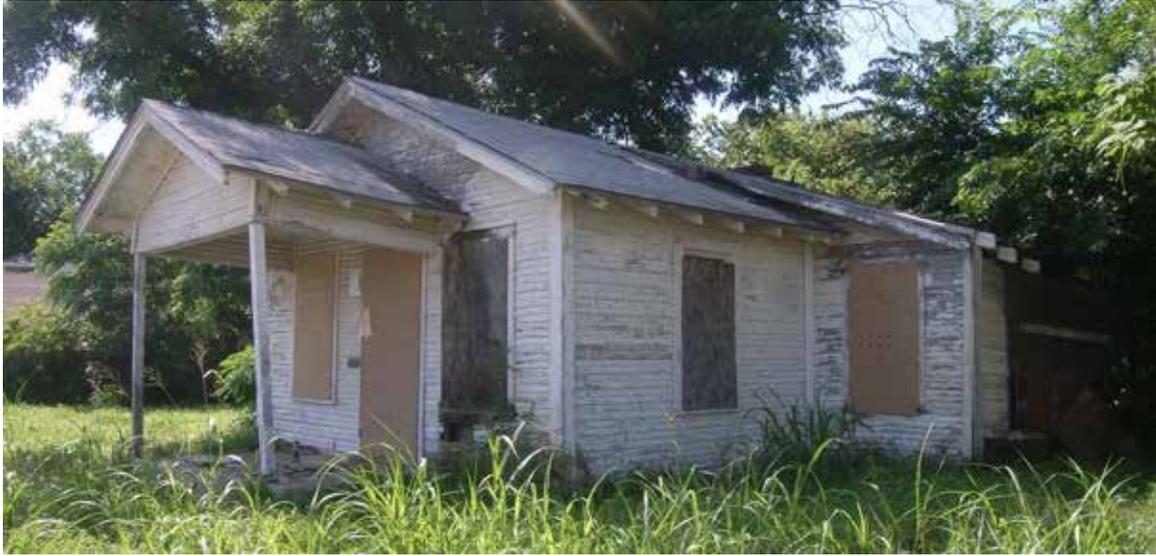
West Elevation

The residence is in poor condition due to deterioration and neglect. The foundation is in need of repair. The roof is sagging significantly and a portion of the roof on the west elevation has collapsed. There are several other holes throughout the structure. The exterior walls are bowing, particularly on the west elevation. The gap between the roof and the wall is several inches to a foot wide in places. There is significant water damage on the interior. The ceilings, floors, and most (if not all) interior walls will likely require complete reconstruction. The floors are spongy in every room.
