**STAFF REPORT  
HISTORIC AND CULTURAL LANDMARKS COMMISSION  
CITY OF FORT WORTH, TEXAS**

DATE: December 12, 2016

<b>REQUEST</b>	Certificate of Appropriateness
<b>APPLICANT/AGENT</b>	William Ryan Perry
<b>LOCATION</b>	1932 6 <sup>th</sup> Avenue
<b>ZONING/ USE (S)</b>	B/HC
<b>NEIGHBORHOOD ASSOCIATION</b>	Fairmount Southside

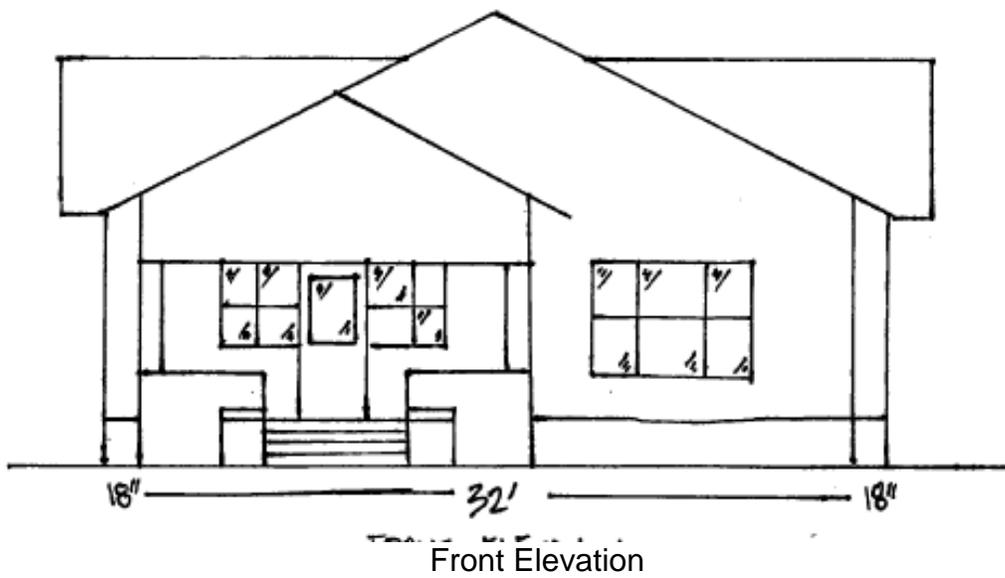
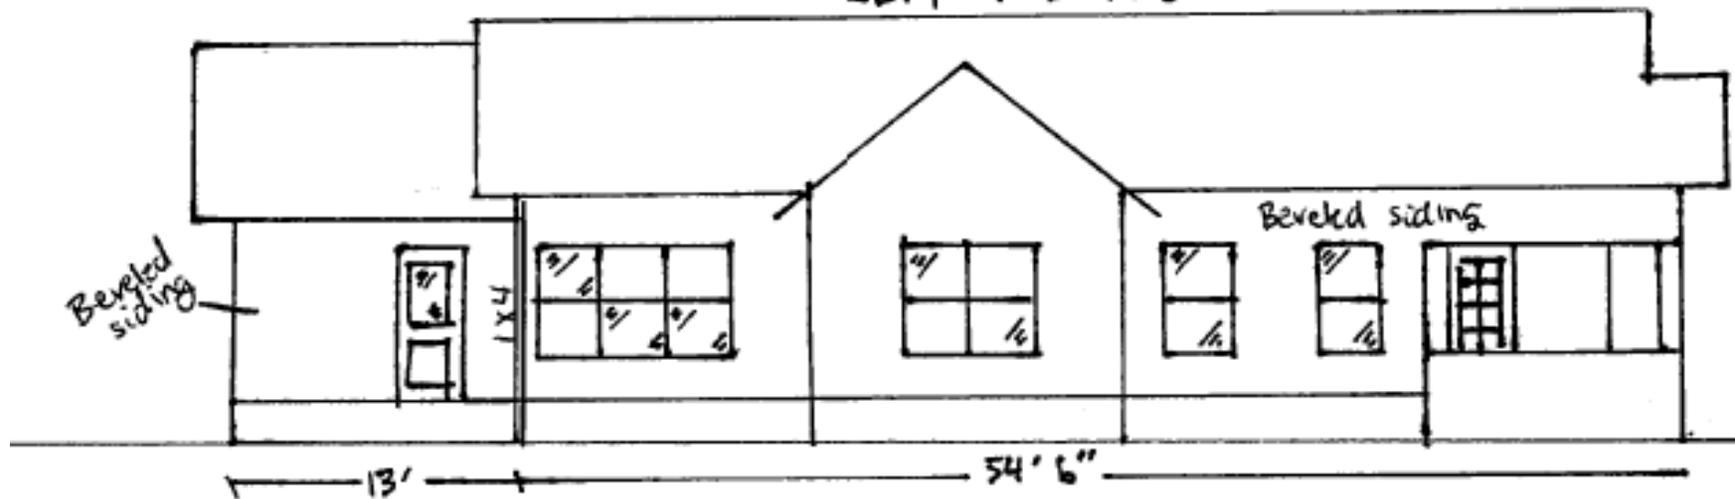
### LEFT ELEVATION

The proposal is to construct a single-story addition to the historic main house using materials that match the existing bungalow. The height and overall scale of the proposed addition is compatible with the character and appearance of the District and it tucks under the main gable, expressing a key preservation principle of establishing a subordinate relationship between the historic property and the addition. That the side wall that coincides with the historic wall plane hampers the subordinate relationship in plan, resulting in the concealment of a large portion of the historic corner of the house.

- a. **That the addition be sufficiently set-in to maintain the three-dimensional qualities of the historic corner;**
- b. **That the existing and proposed exterior materials be shown on the elevations; and**
- c. **That the drawings be revised to reflect the above conditions prior to the issuance of the COA.**

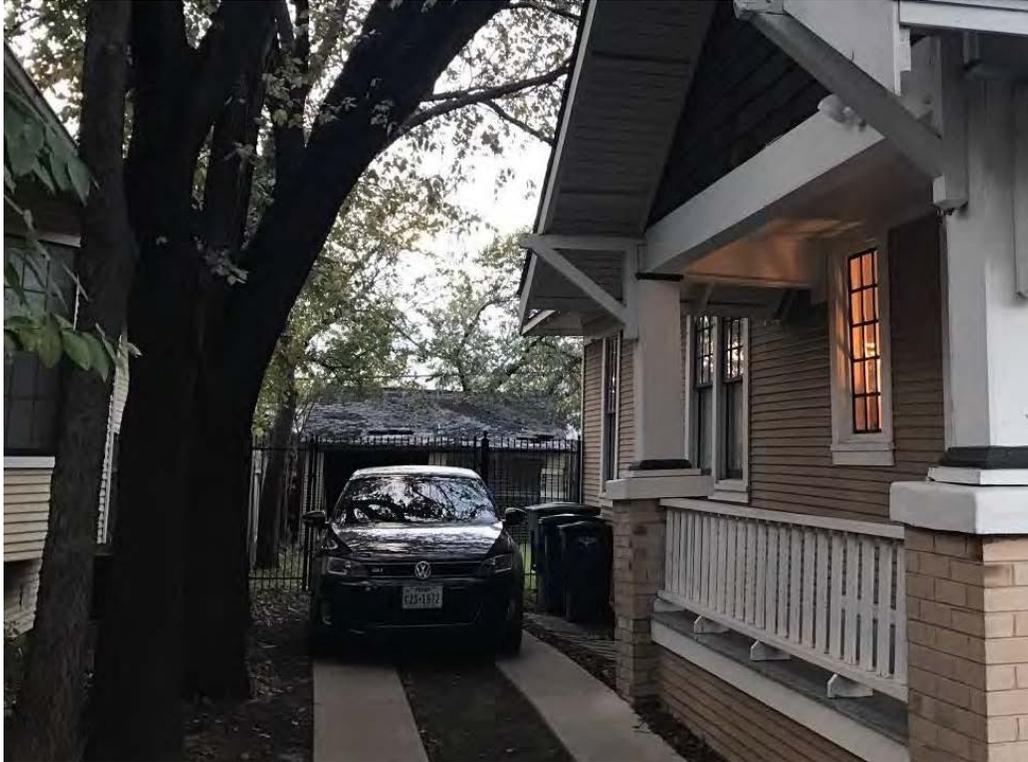
The applicant is requesting demolition of the existing accessory structure. It is a two car garage with a side gable roof, clad in 117 wood siding. The structure is missing the original carriage doors and windows. The window openings have been boarded. The structure is in a deteriorated state. There are holes in the roof and the structure is slightly leaning. The structure's foundation is inadequate. Often accessory structures in the Fairmount Historic District were built without reinforced concrete foundations. The foundation issues, along with the holes in the roof and improperly boarded windows have resulted in significant water infiltration causing the wood framing of the structure to rot.

Accessory Structure as seen from Driveway

Staff recommends the following motion: **Motion to approve.**
