**STAFF REPORT
HISTORIC AND CULTURAL LANDMARKS COMMISSION
CITY OF FORT WORTH, TEXAS**

LOCATION 1604 E Hattie St

**CITY OF FORT WORTH
CODE COMPLIANCE DEPARTMENT
BUILDING SURVEY**

Notice of Violation

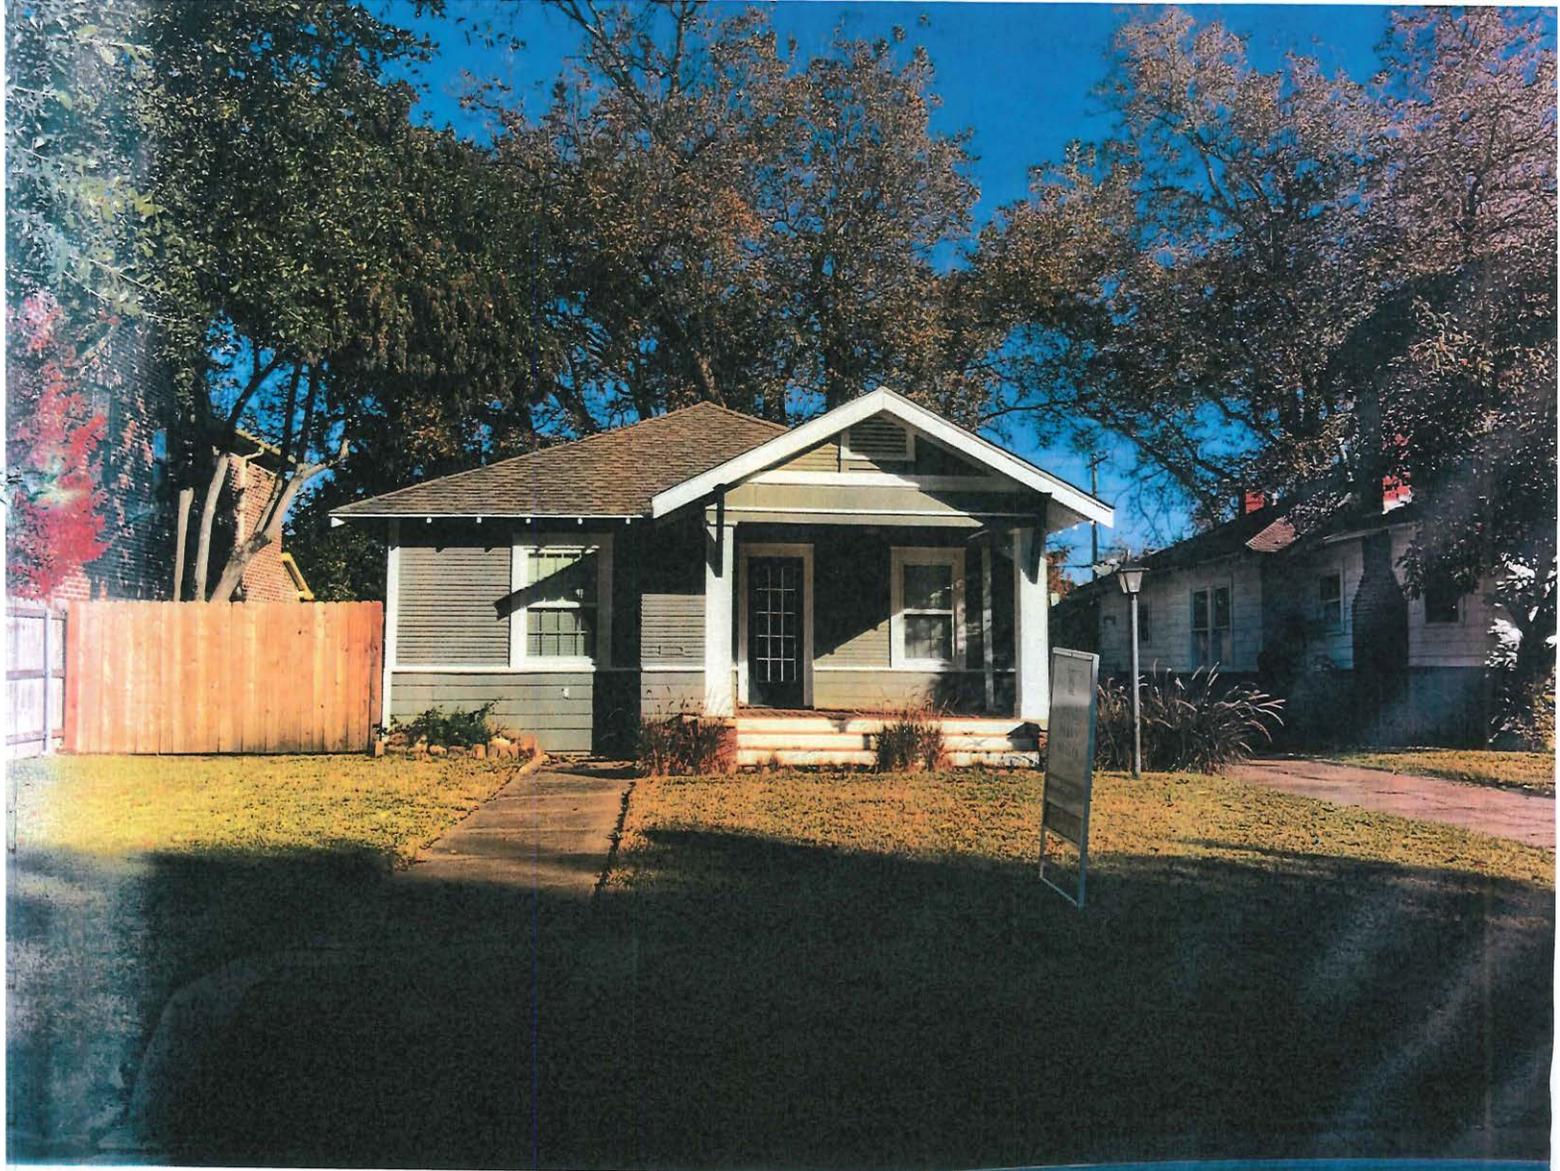
Street view

The main structure has wood and aluminum siding. This detail along with the form and setback of building contribute to the setting of the Terrell Heights Historic District.
