STANDARDS AND GUIDELINES FOR SIDING AND MASONRY

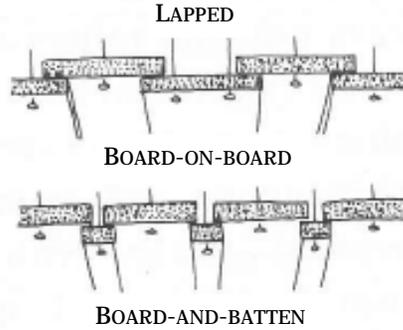
BOARDS, VERTICAL

In the image to the right from *A Field Guide to American Houses* by Virginia and Lee McAlester, you can see that vertical siding is often lapped with either board on board or with a batten.

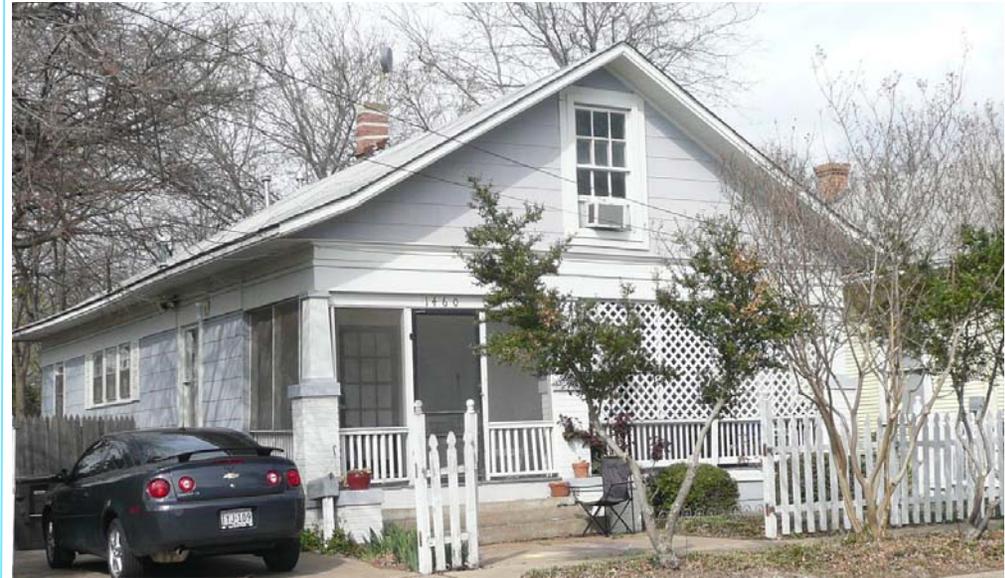
Asbestos siding became popular at the beginning of the 20th century. With appropriate maintenance, asbestos shingles can be expected to last over 30 years. The EPA banned asbestos in 1973, as a result, the repair of asbestos roof shingles and siding is not always feasible. If more than 20% of siding is damaged then replacement is most likely warranted. **The removal of asbestos siding and the restoration of the wood siding is encouraged.**

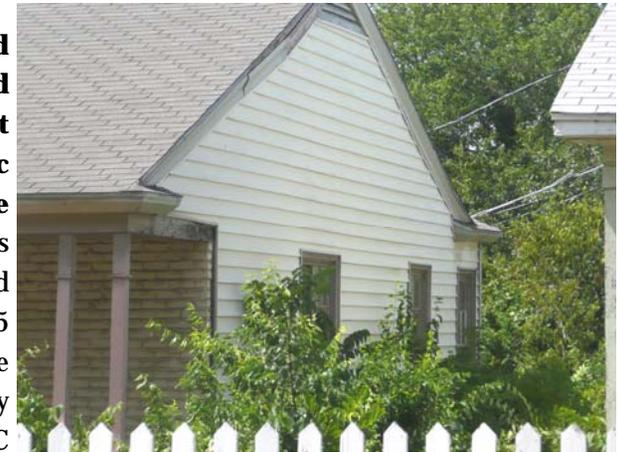
ABOVE: The structure has a brick veneer on the front and inappropriate vinyl siding at the side.

Artificial siding and veneers such as vinyl and asphalt siding are not appropriate for historic districts are not suitable materials. Currently there is not a cement fiber board available in the prominent 105 and 117 siding profile. As more profiles become available they will be reviewed by the HCLC on a case by case basis.

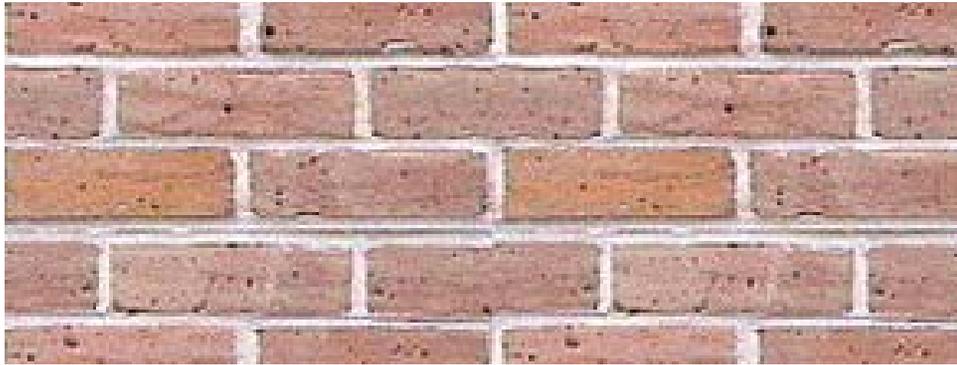
WOOD MOLD BRICK– Is wet or dry clay that is pressed into a wood mold allowed to dry and then fired. Depending on the firing method used strength (soft vs. hard) and color (shade) can vary. These are typically solid. They are most prevalent in structures constructed prior to 1900; however, can still be found today at various brick factories. Wood mold bricks can be identified by their rounded edges and corners and by holes and voids in the surface.

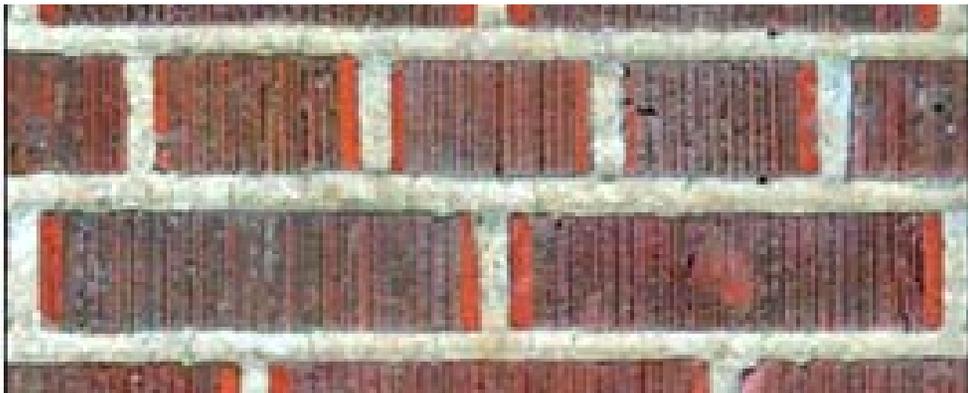
EXTRUDED BRICK– Is very dry clay that is forced through a form (creating a long ribbon) and cut by either a machine or by a wire into individual bricks and then fired. They are often hollow. Because they are produced on a massive scale they are typically very hard and the color (shade) is more consistent. These bricks were popularized in the early 20th century. Extruded brick can be identified by its smooth surface and hard edges and corners. Wire cut brick can be identified by a series of vertical ridges in the surface and by hard edges and corners.

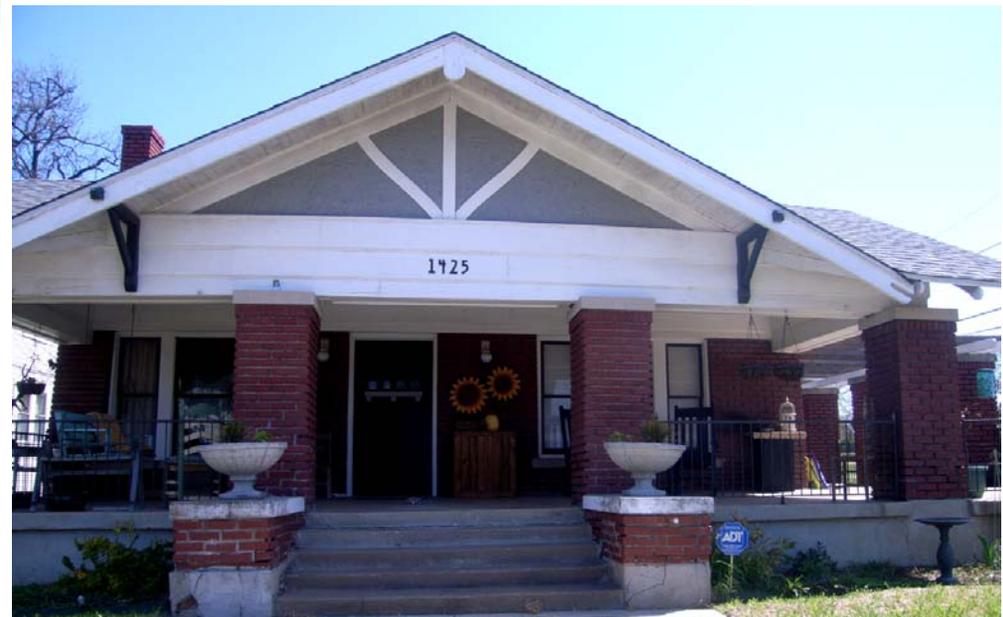
Masonry veneer is most commonly found in 20th Century structures. These are wood frame buildings that are clad in brick, stucco or stone. The masonry materials on these building are not structural and are purely decorative. After World War I, veneer techniques advanced significantly and thus more homes were built using this technique.

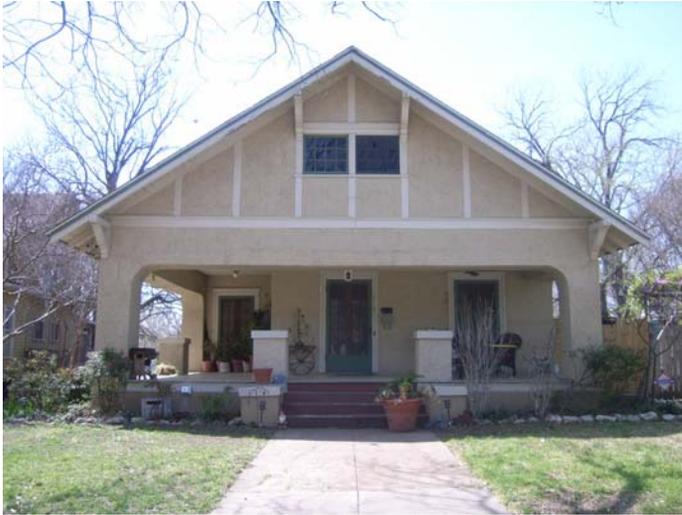
LEFT: The half timbering in the front gable of this structure identifies it as an Arts and Crafts structure, but it also serves as expansion and ventilation joints for the stucco veneer.

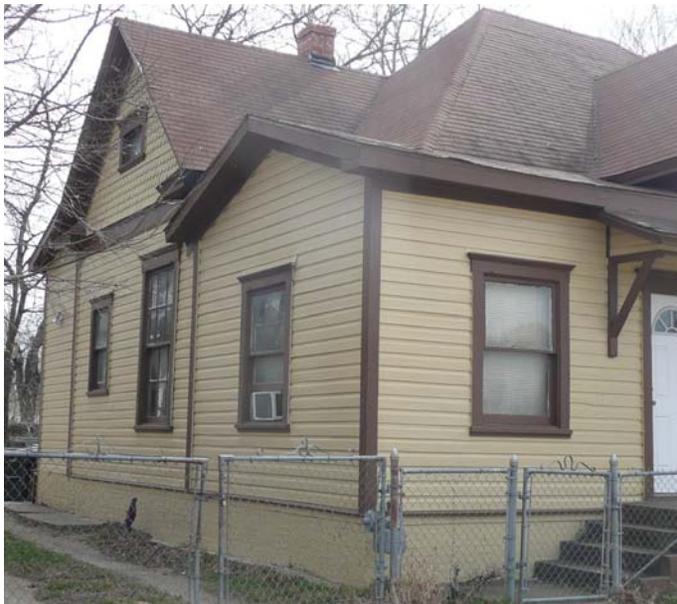
RIGHT: The corner boards, fascia and trim surrounding the windows unit creates a water tight seal at the siding joints. The trim provides weather proofing to the interior wall system and decreases water intrusion.
